LAKEVIEW PARK DAM

ST. FRANCOIS COUNTY, MISSOURI

MO 30288

**PHASE 1 INSPECTION REPORT
NATIONAL DAM SAFETY PROGRAM**

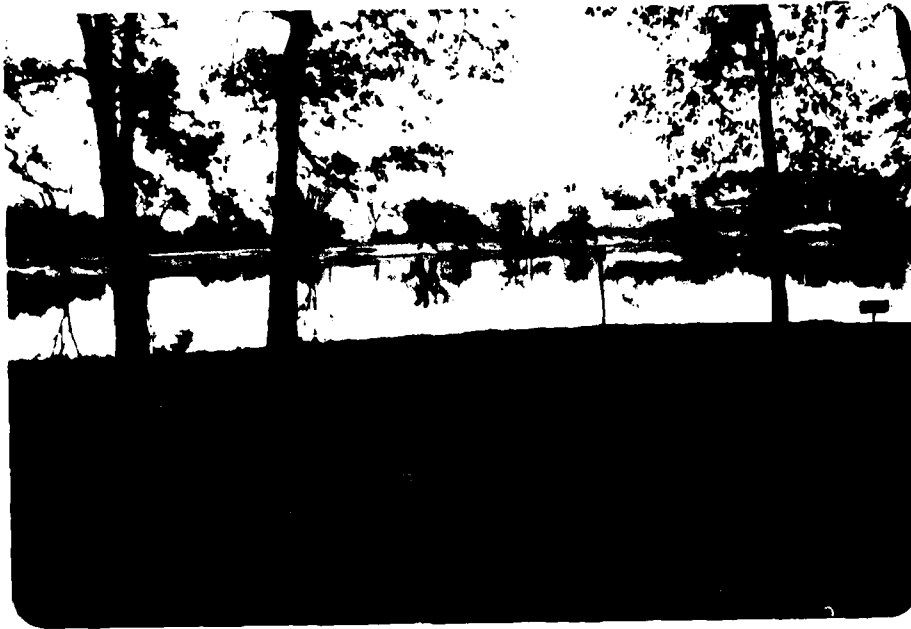
PHOTO NO. 2 - OVERVIEW FROM LEFT UPSTREAM BANK
